T-11300/2

11/26/80

REPLACE DIGESTER COVER, DIGESTER S-716, HADNOT POINT SEWAGE TREATMENT PLANT

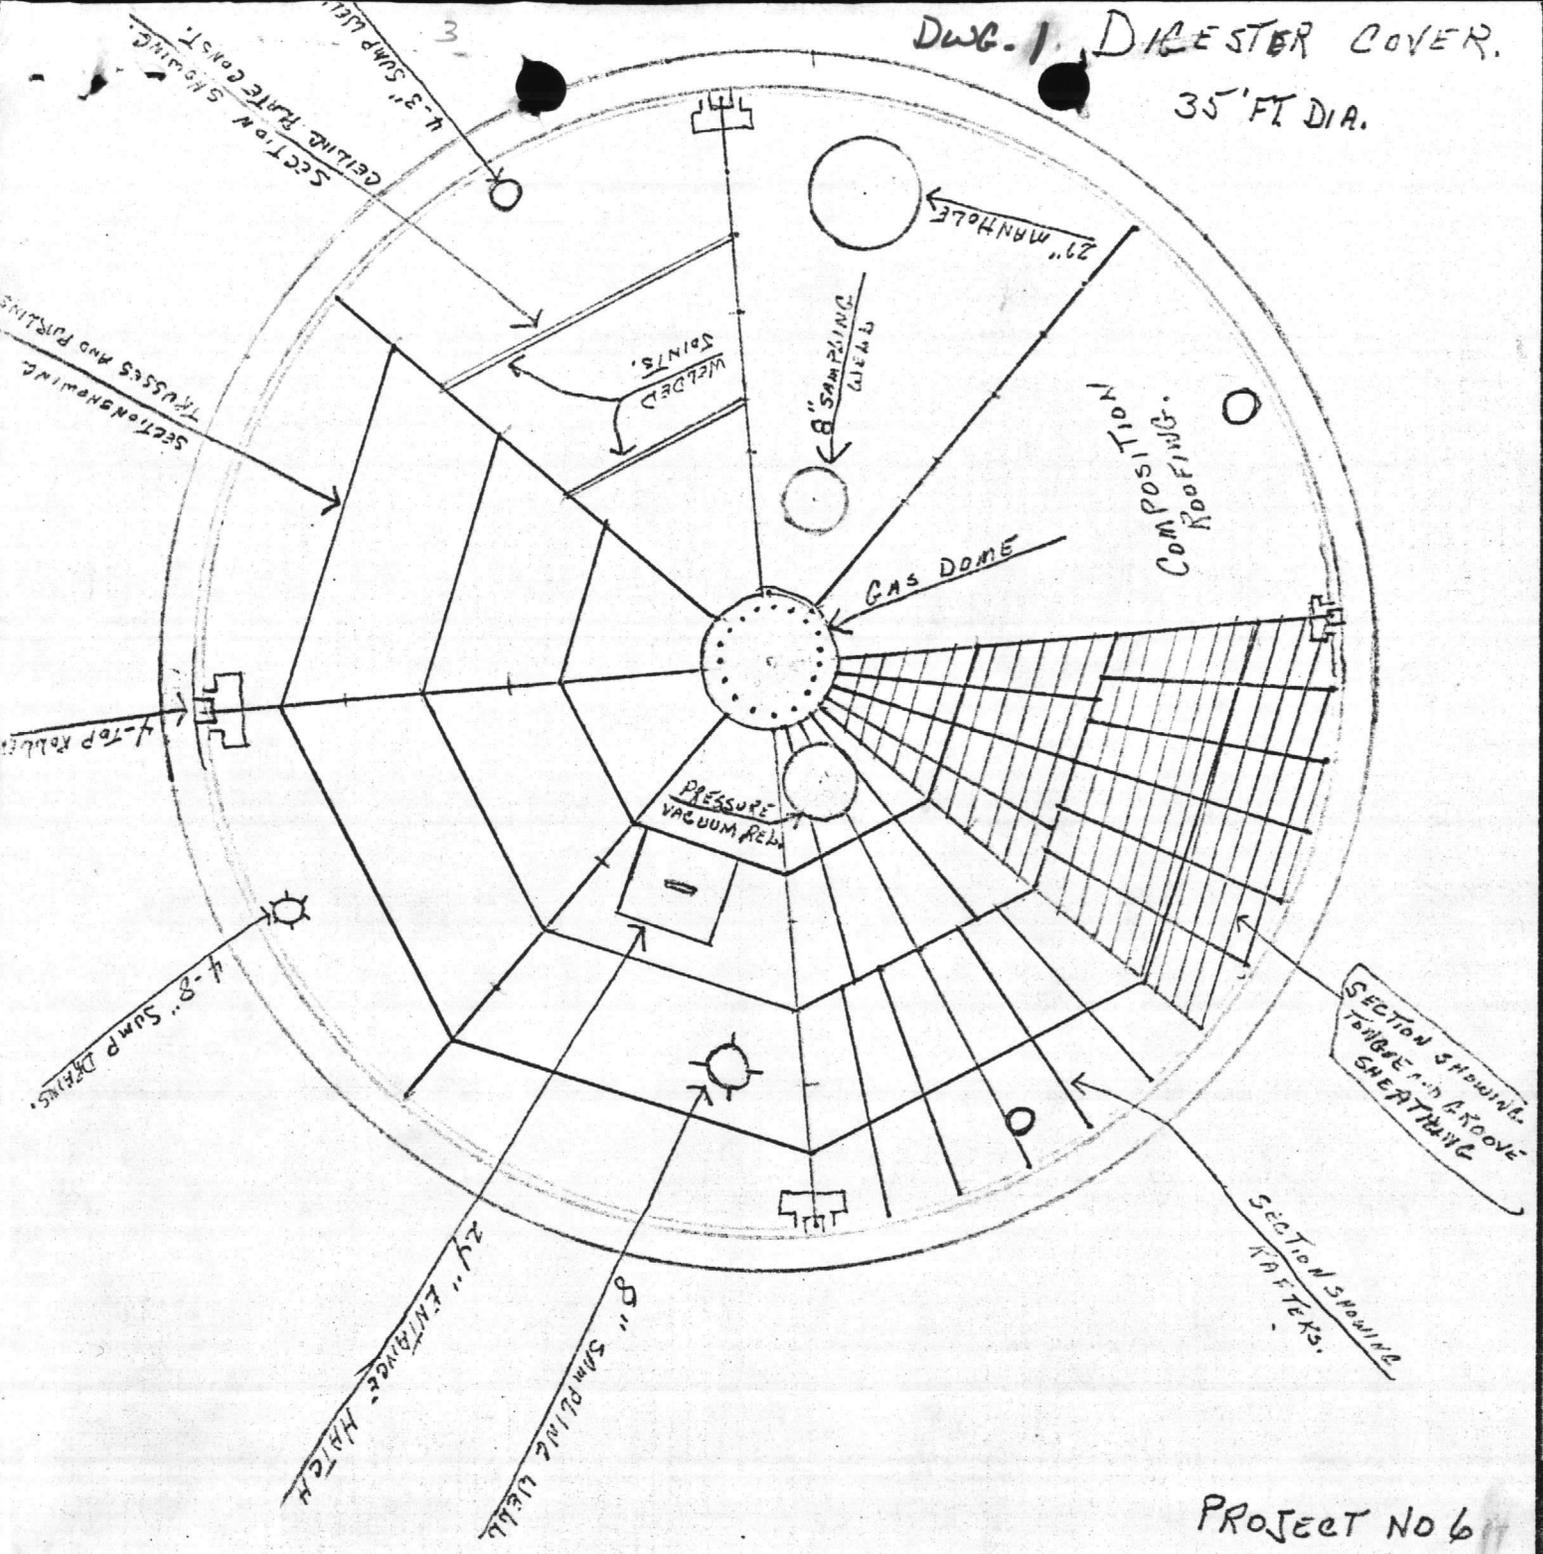
DWG. 1. DIGESTER COVER.

The digester at this plant was built in 1943. The digester composition roof has cracks and holes in it; the rain has kept the rafters and sheathing wet, and they have rotted. The metal supports in the cover have rusted and pitted to the point that their structural integrity has been affected. Accordingly, the entire digester cover should be replaced.
